# Steel Flange Reinforcing Joint Repair Joint for Flange

# RJF

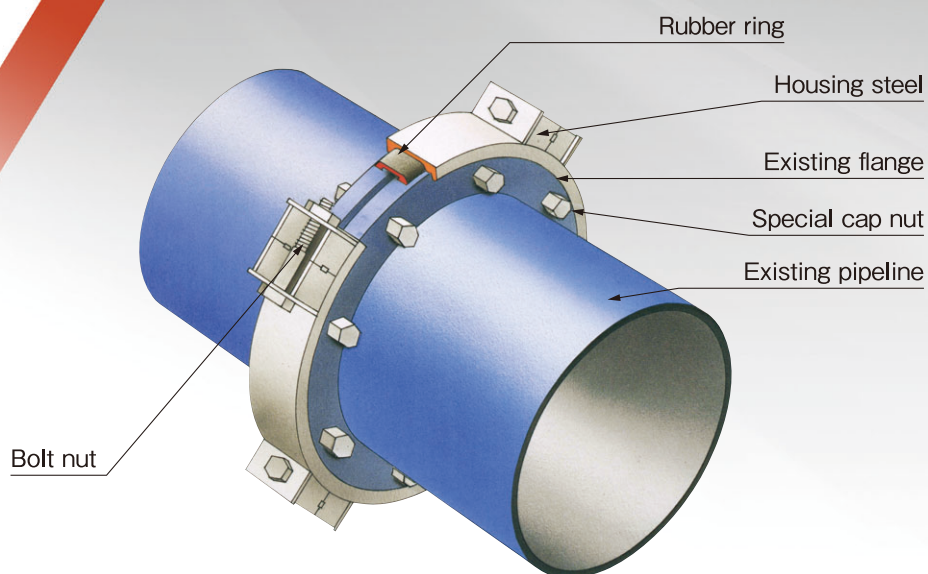
Leakage due to corrosion or opening of the flange can be repaired without cutting off the water supply. Custom-made to match the existing flange, so it can be adapted to any situation. Rubber ring with automatic sealing mechanism is used to achieve continuous water sealing performance.

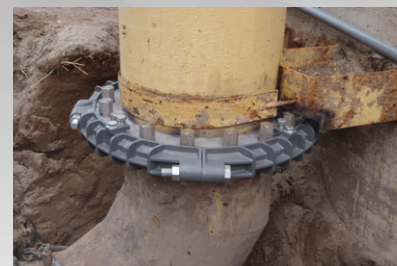
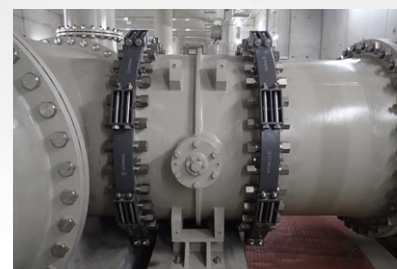
Material: SS400, SUS304  
Size: 3"/DN80 ~ 80"/DN2000  
Rubber ring: SBR, EPDM, Silicon etc.
